APPENDIX A: Photographic Log of the LWSC Dam Survey

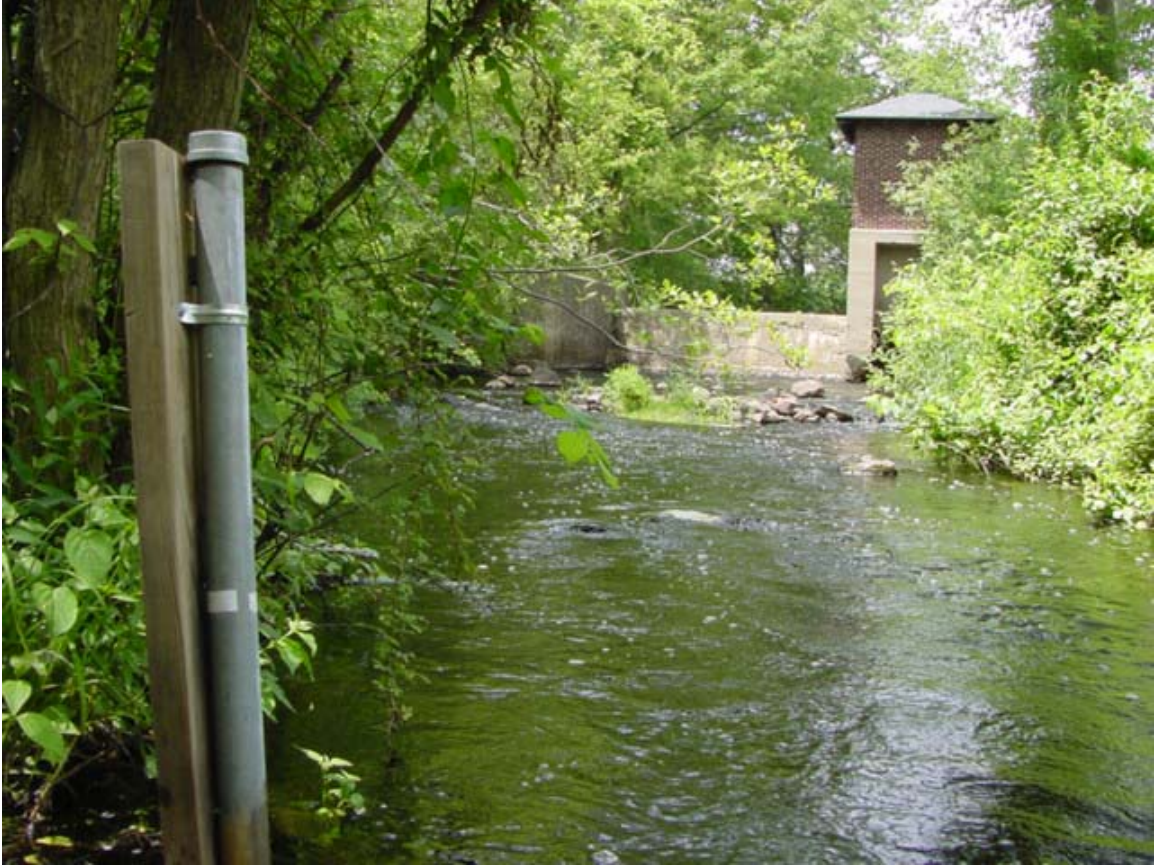
Massachusetts Riverways Staff Gage located downstream from the LWSC Diversion Dam (seen in background) along the right bank of the Saugus River. Gage readings are collected once daily.

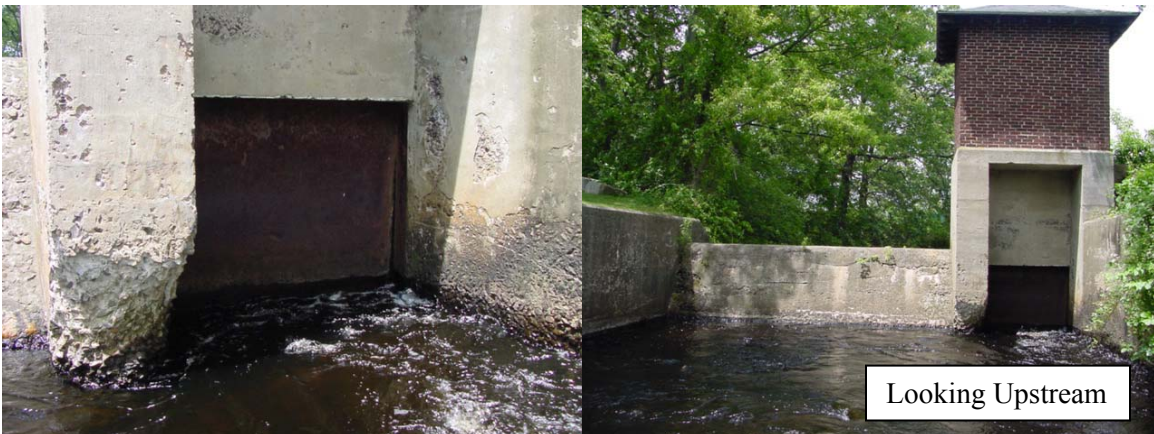
Flow passes through a 3" opening in the sluice gate (shown at left and again at right)

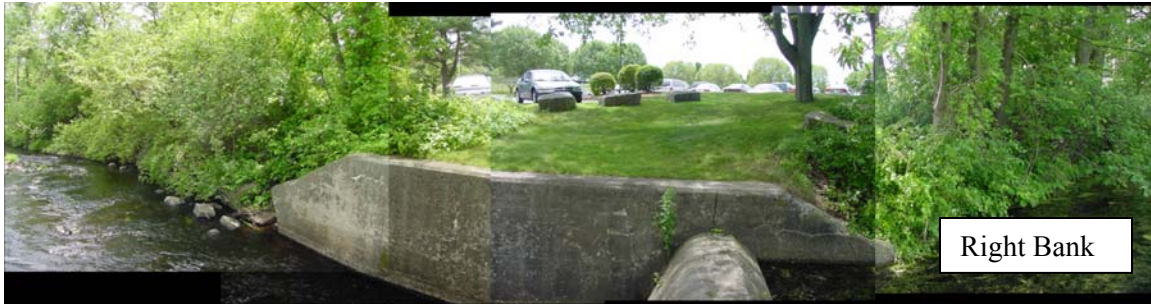
A local benchmark (nail, elevation 52.58 feet) is located in the top of the right training wall. The dam crest elevation is approximately 50.6 feet). “Measure-downs” to the headpond are taken from a notch approximately 2 inches below the top of the training wall. Headpond elevation is collected once daily.

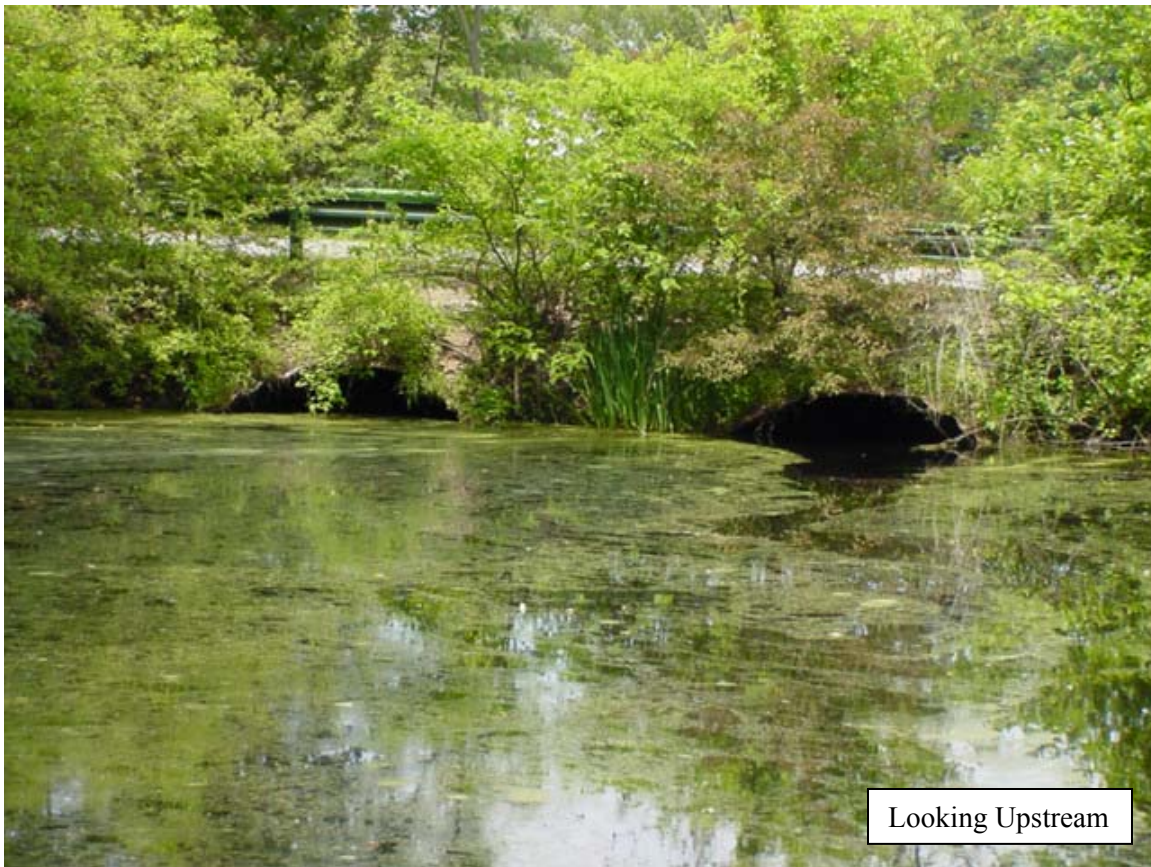
The headpond extends upstream through a set of corrugated steel culverts (shown at center, above) that convey flow under a road connecting the hotel to the golf course and fitness club.

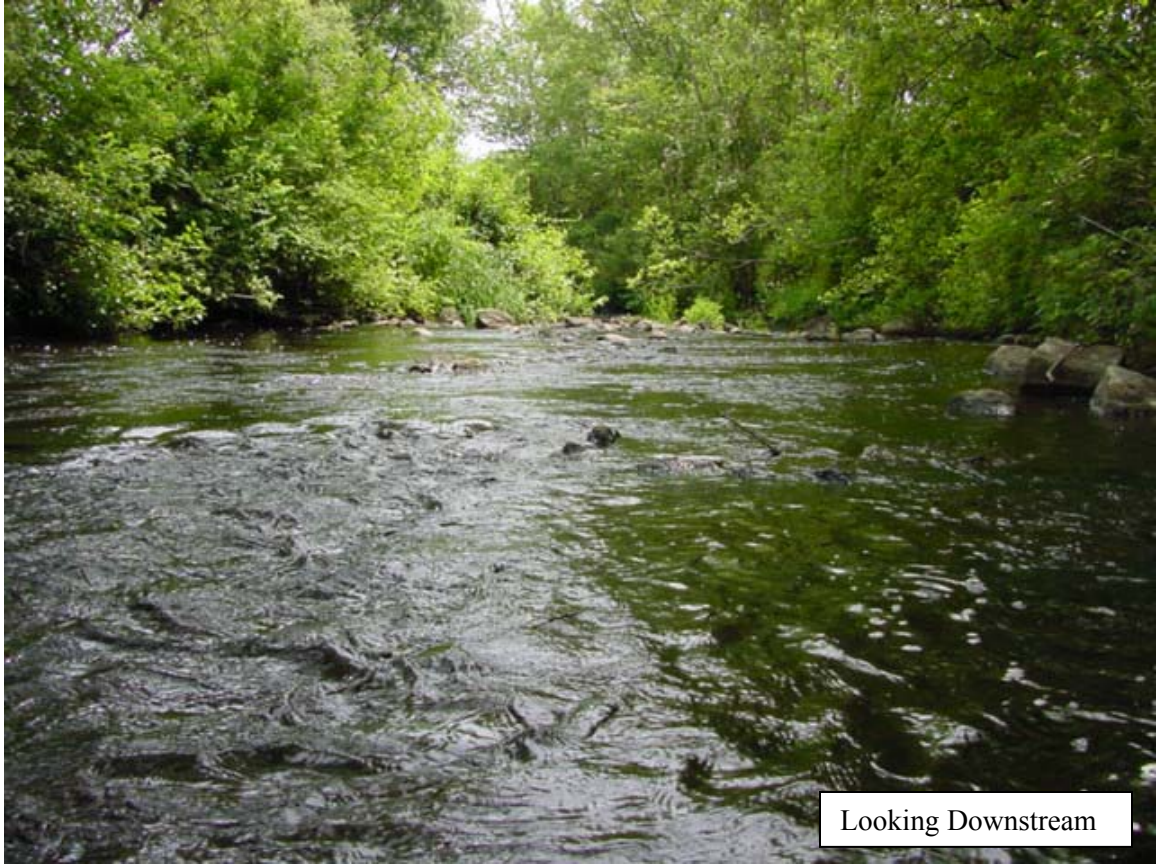
A pile of rocks (shown in the foreground, above) at the foot of the dam apron creates a backwater pool and forces the majority of flow through a winding thalweg (located at left). Another artificial rock pile may need to be constructed to maintain the necessary water level (minimum 8" deep) at the foot of the fishway.

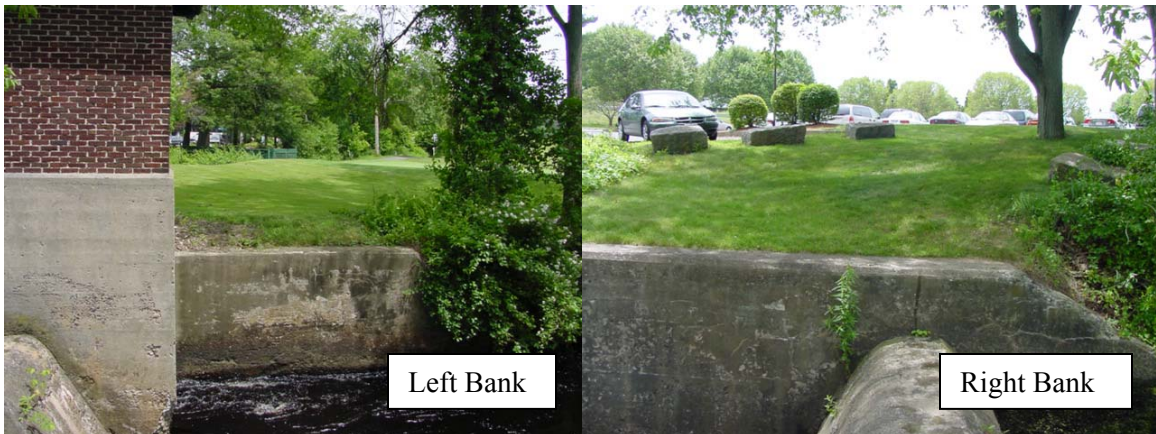
The channel is along both banks: a parking lot (right bank, shown at right), and a putting green (left bank, shown at left).
